Socket Size Irregularity

This Technical Bulletin affects the following Reliance products :

- 3022-17 Socket
- 3022-2 Remote Pole with Socket

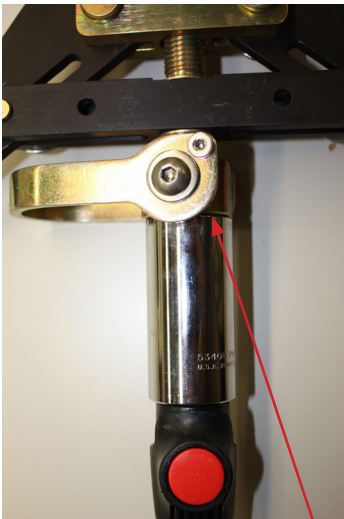
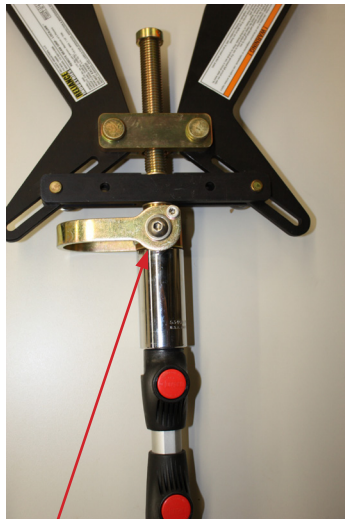
A properly seated socket is flush against clamp.

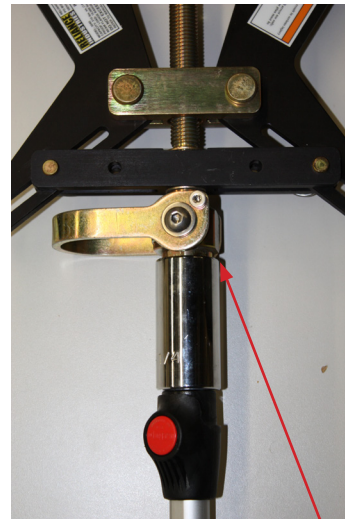
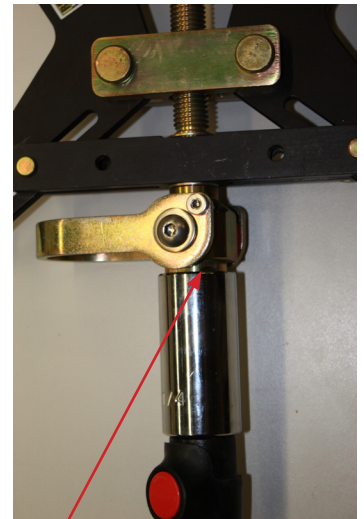
Issue : The 3022-17 socket Original Equipment Manufacturer (OEM) recently made a change to the interior dimensions of the 3022-17 socket. The result of this change is that the new socket well is not deep enough to properly engage the ball-detent with the corresponding notched grooves inside the socket.

Improperly seated socket is not flush against clamp.

The correct socket should have two sets of notches on each of the socket walls, and should seat flush against the clamp. If you are in possession of a socket that does not fit properly, or has only one set of notches in the socket walls, please contact Reliance for further instructions.

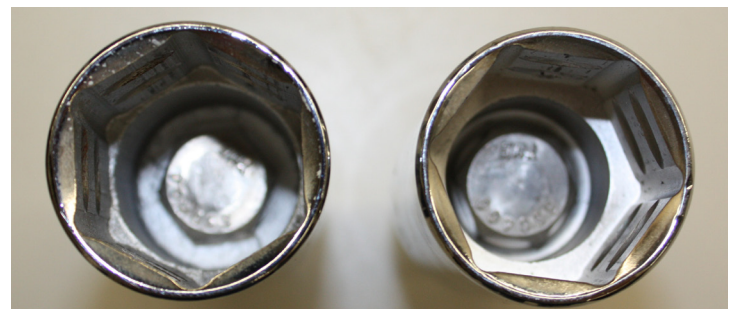
Correct (Left) & Incorrect (Right)

Wall of socket at bottom is thinner in the correct version of the socket. The wall thickness in the incorrect version is not deep enough to properly engage the ball-detent with the corresponding notched grooves inside the socket.
